Bourne Leisure Ltd. Thermal Performance Measurement Report

May 2016

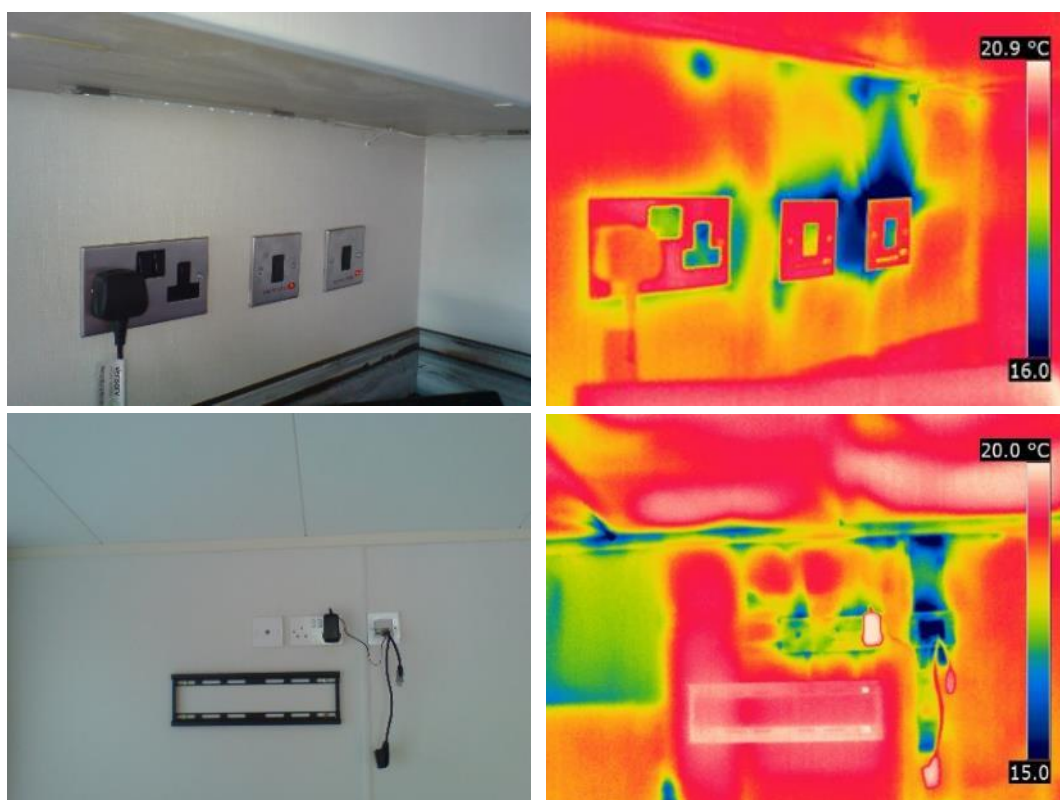
Figure 8 Air leakage around external wall sockets.

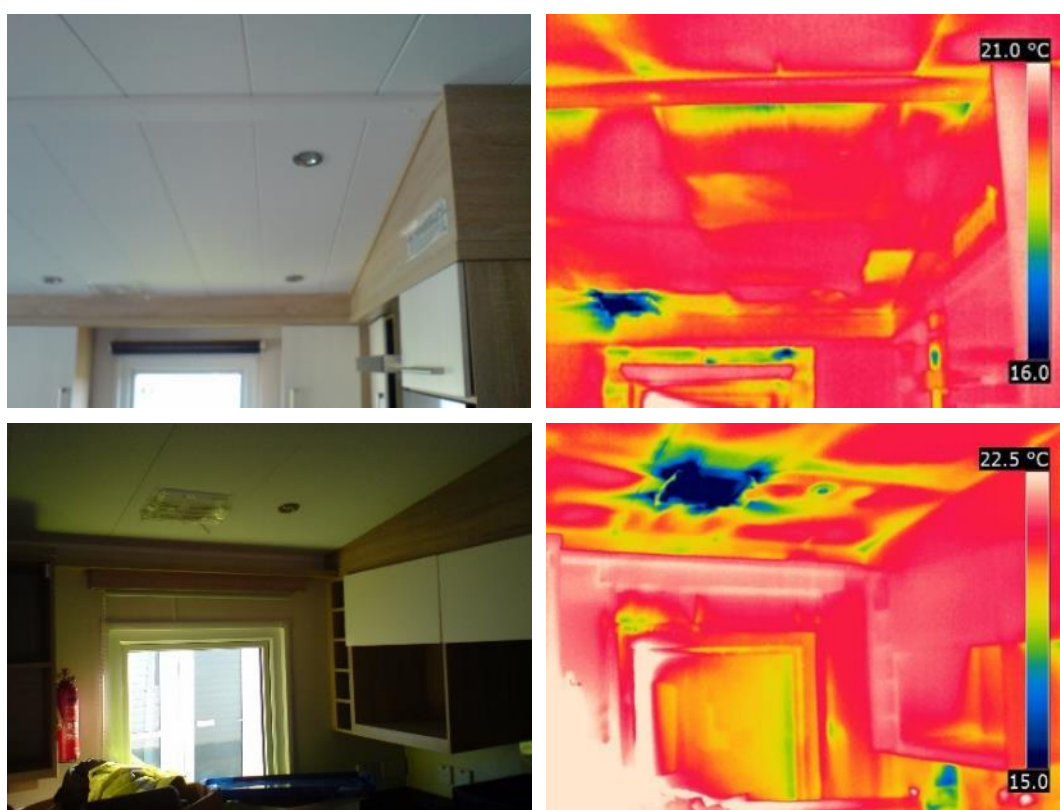
Figure 9 Air leakage around ceiling mounted extract grilles.

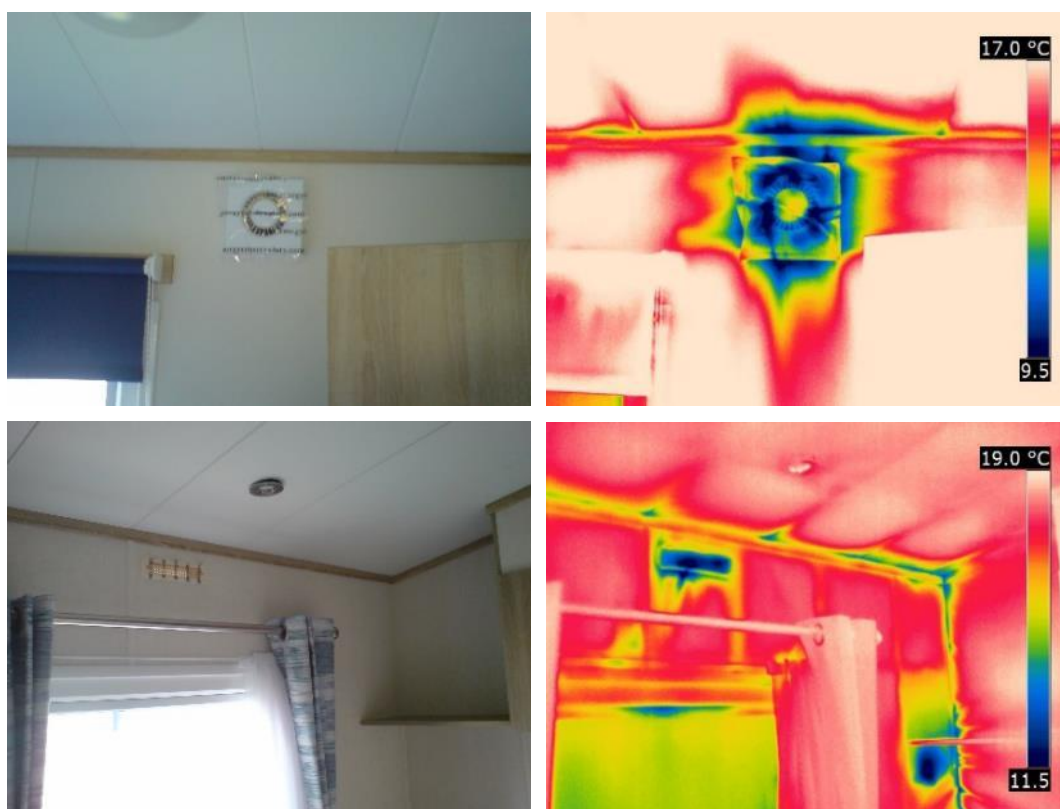
Figure 10 Air leakage around wall mounted extract fans (top) and grilles (bottom).

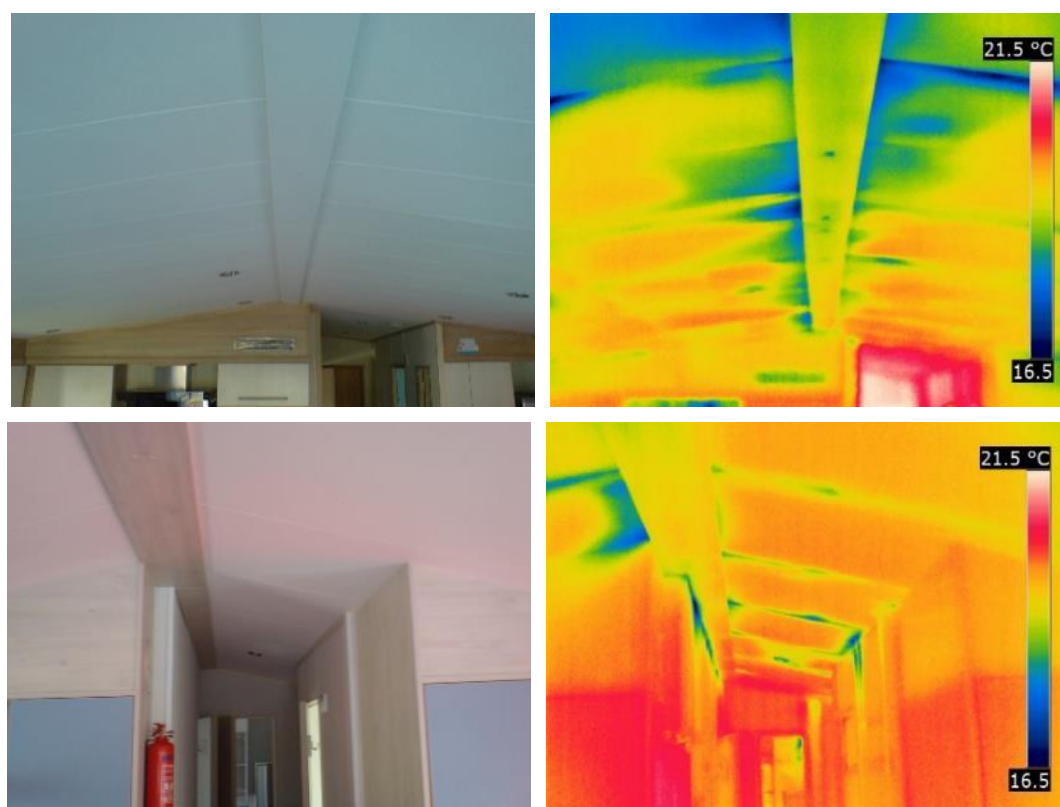
Figure 11 Air leakage at the ceiling ridge junction.

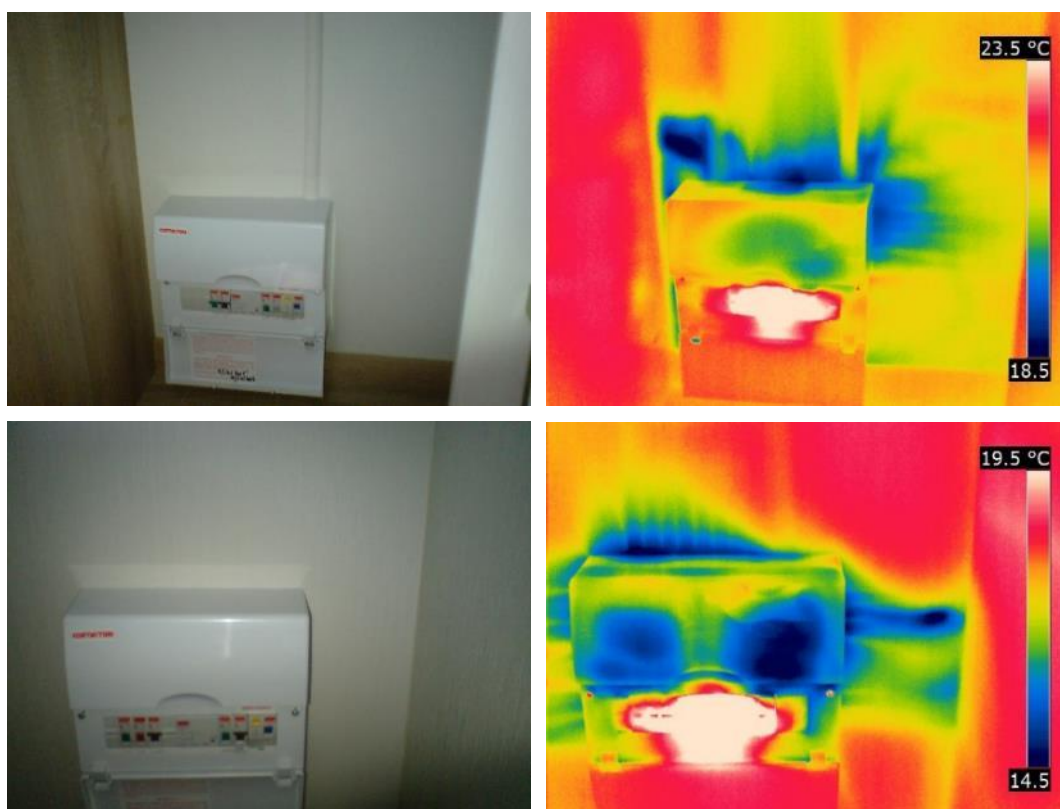
Figure 12 Air leakage around the consumer unit.

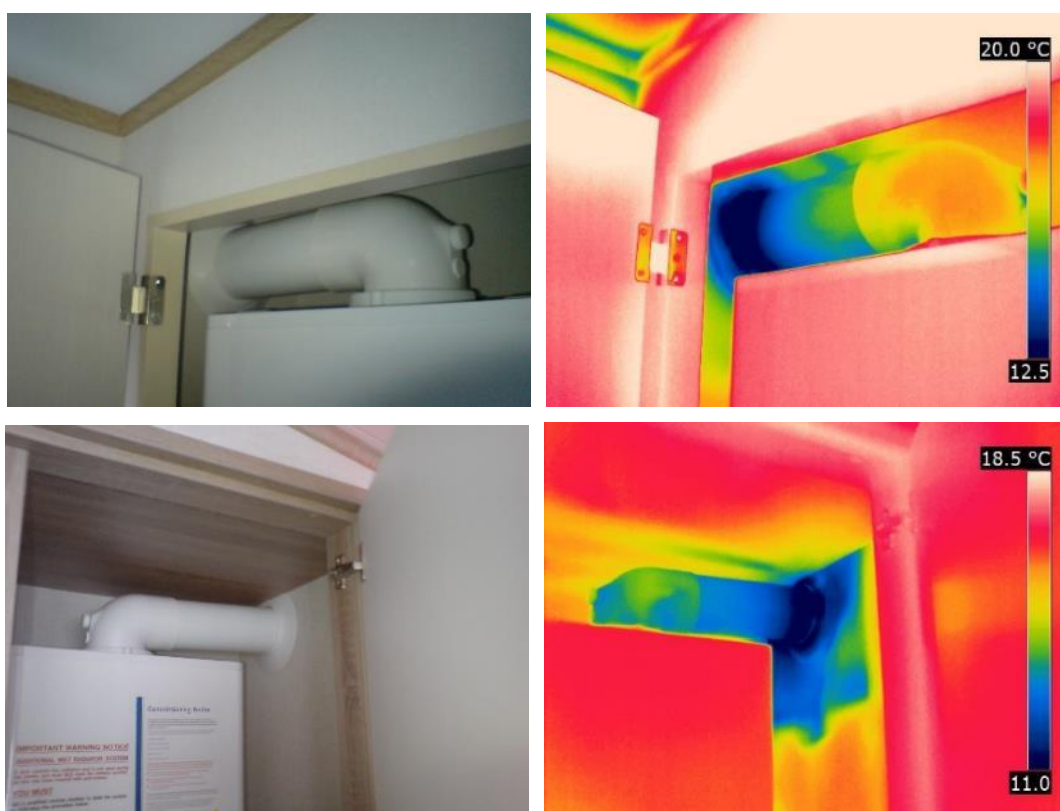
Figure 13 Air leakage around the boiler flue.

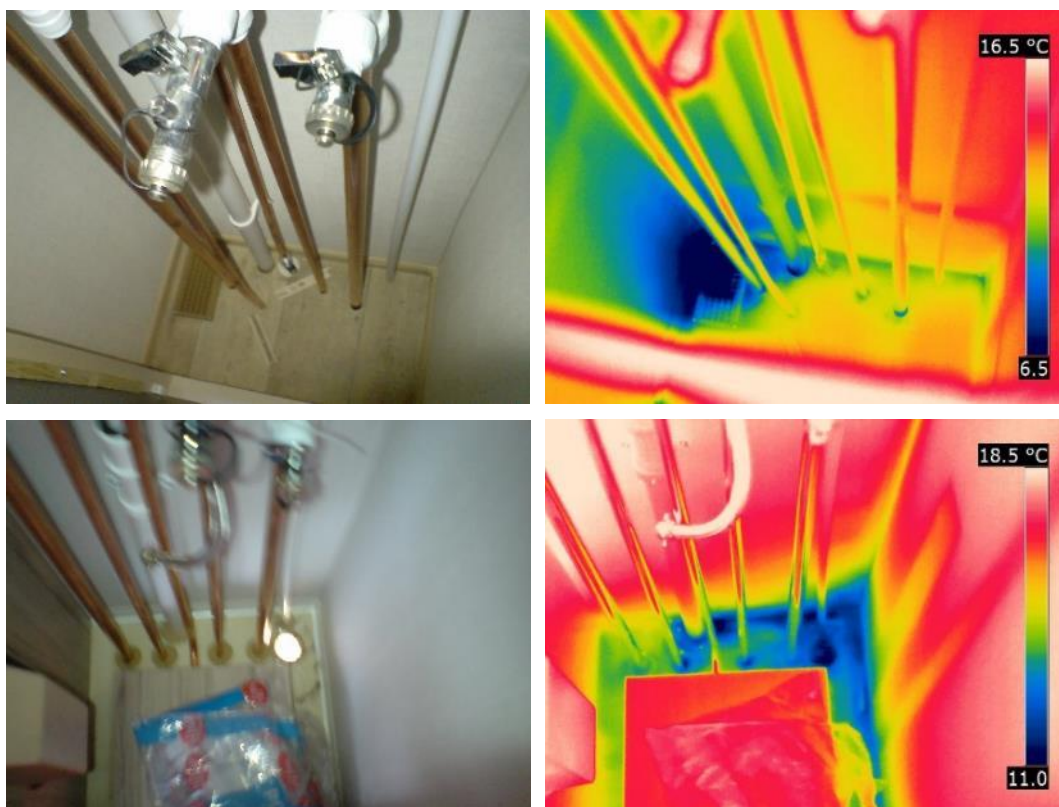
Figure 14 Air leakage around the water pipes, gas pipes and condensate drain at the boiler.

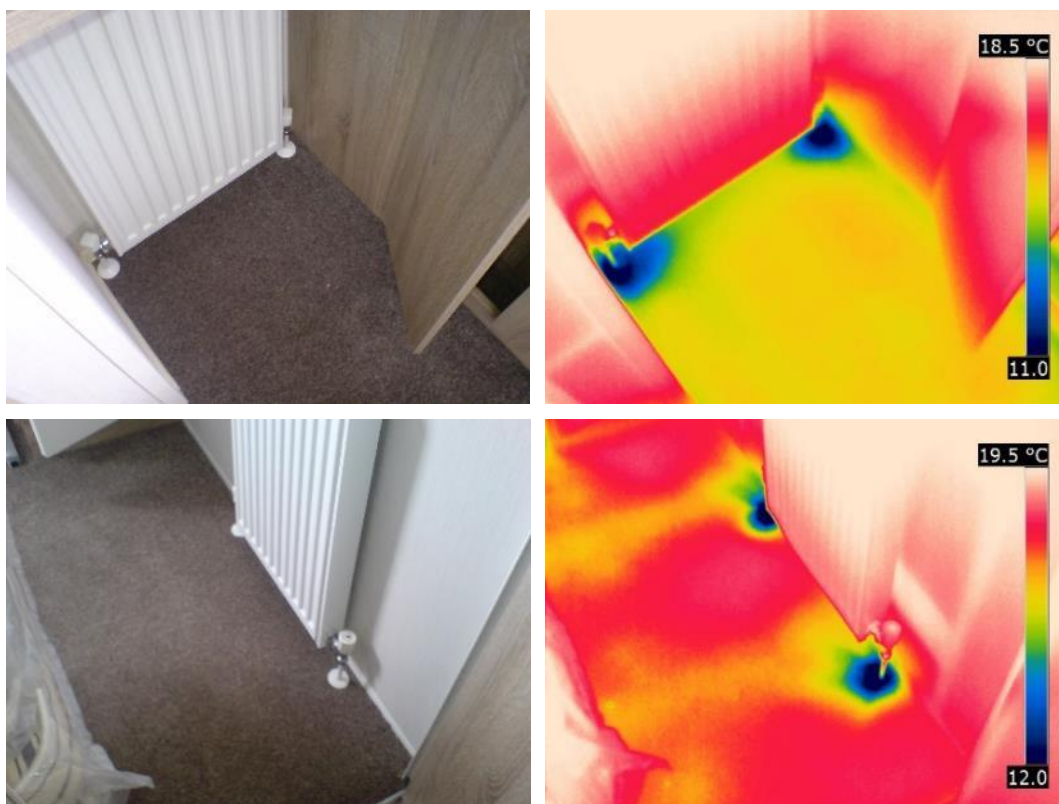
Figure 15 Air leakage around the central heating pipes where they penetrate through the ground floor.

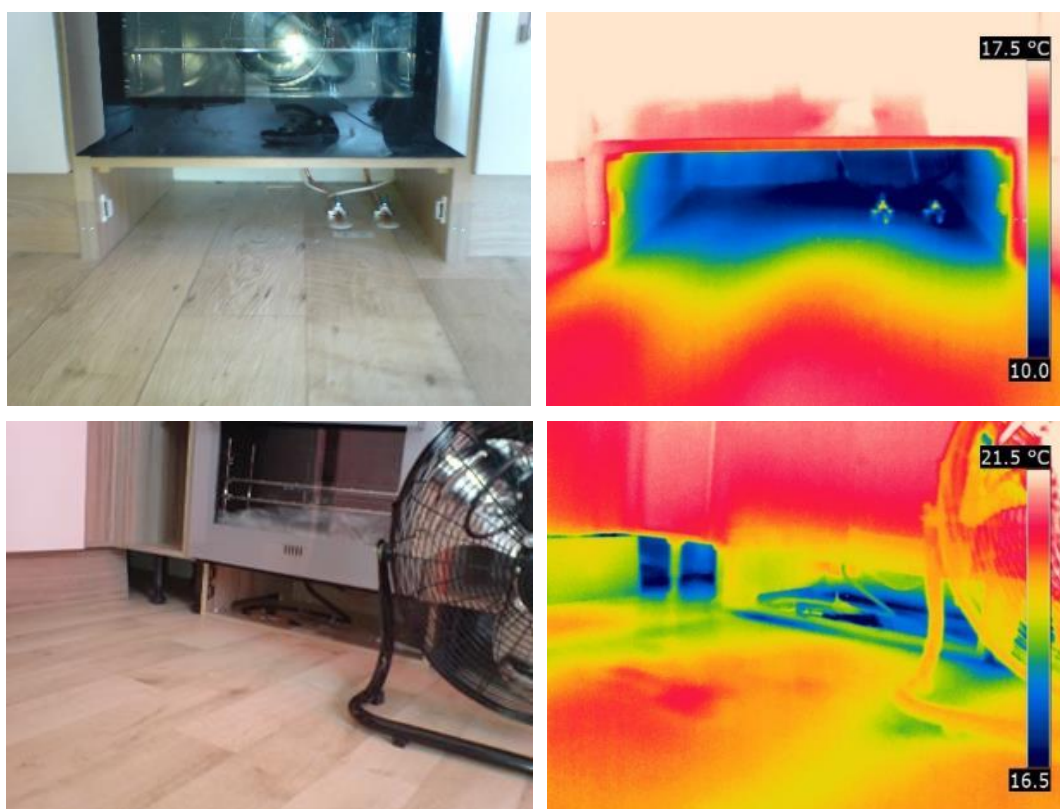
Figure 16 Air leakage around the gas pipes to the cooker.

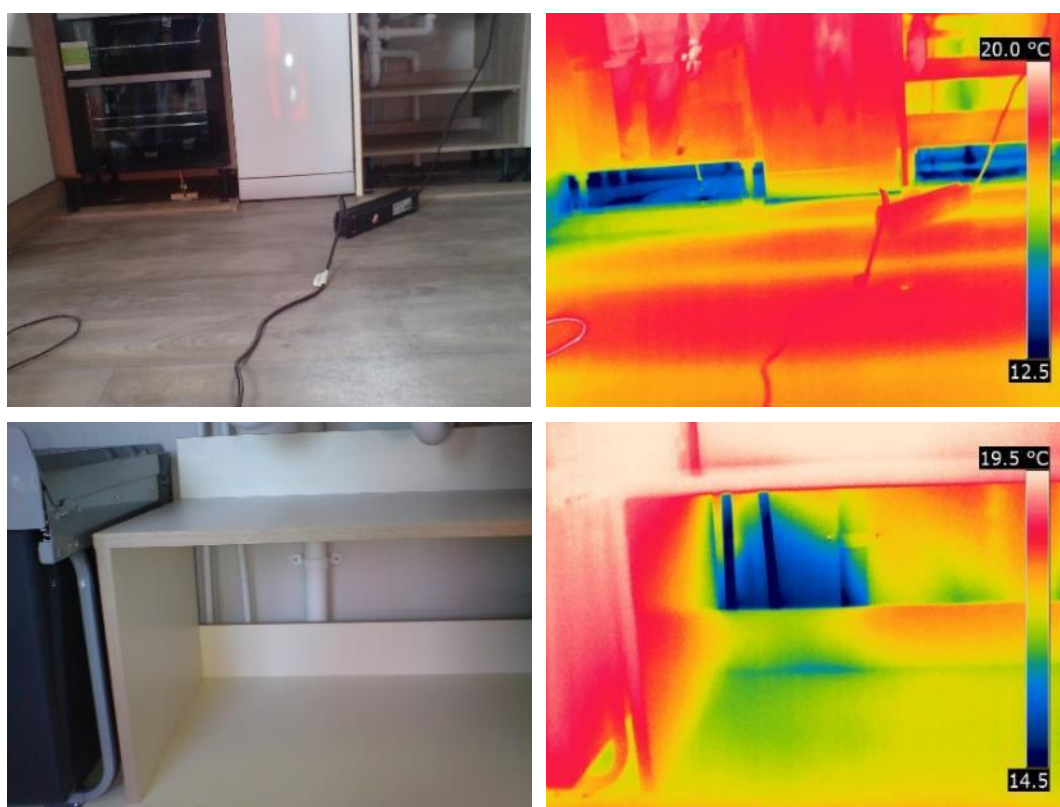
Figure 17 Air leakage around waste and water pipes under the kitchen units.

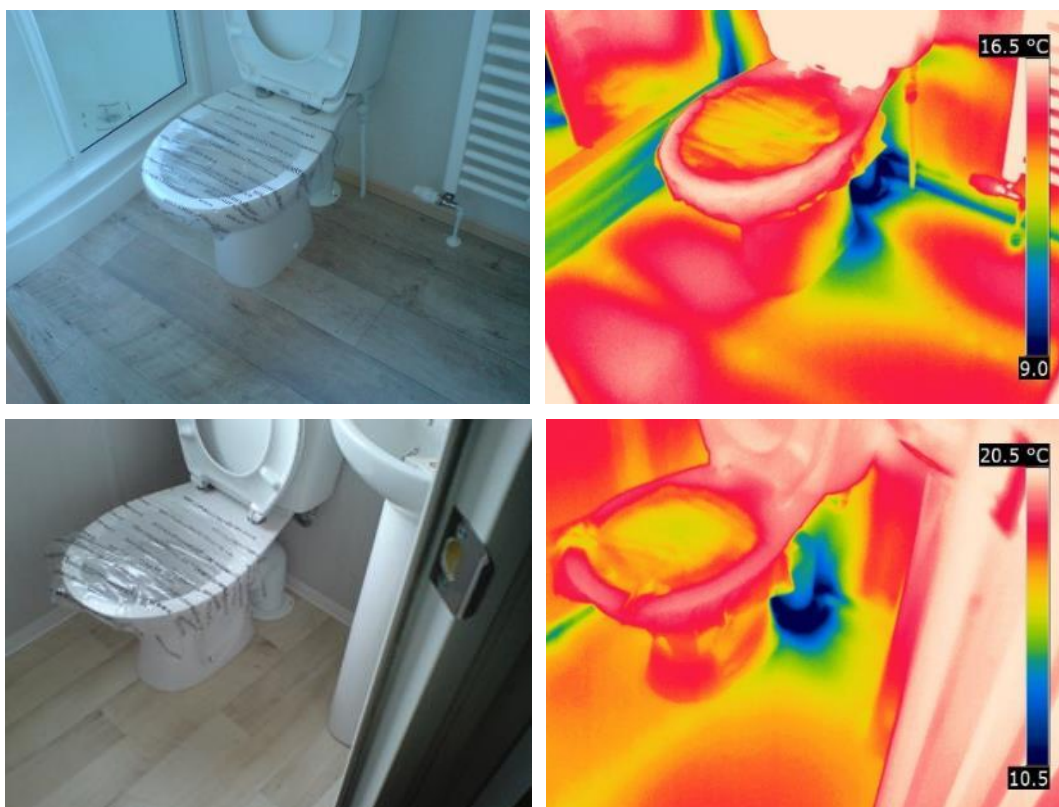
Figure 18 Around the toilet waste pipe.

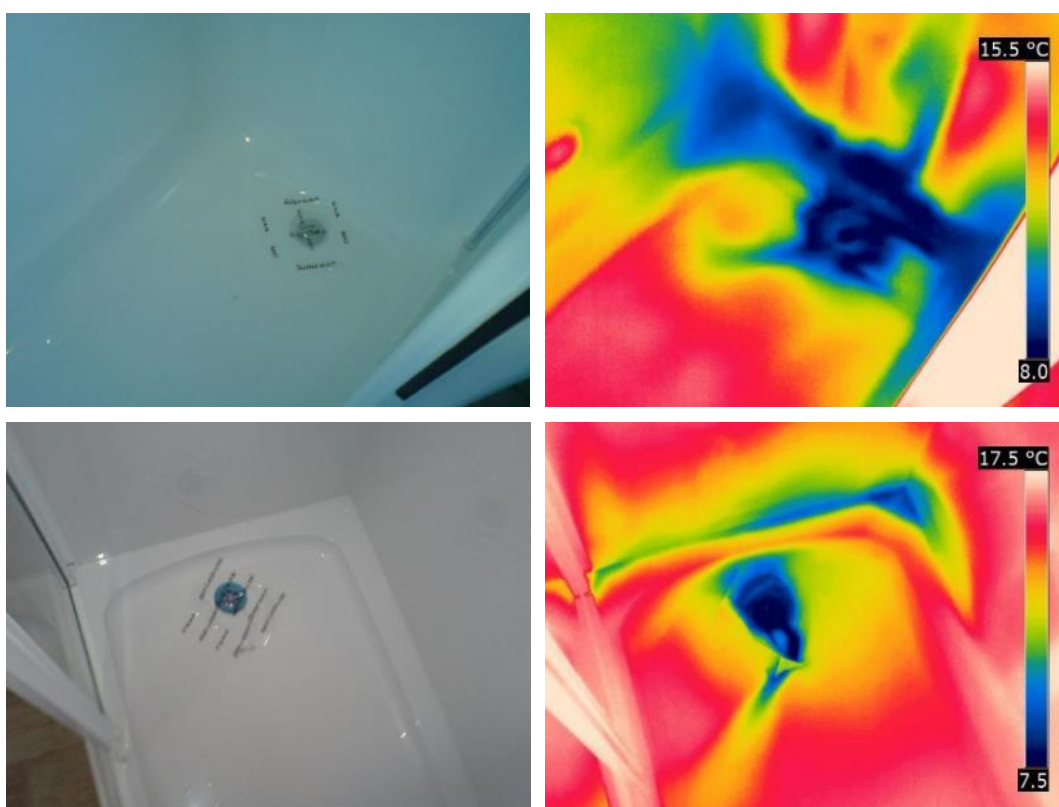
Figure 19 Air leakage from service penetrations beneath the shower tray.

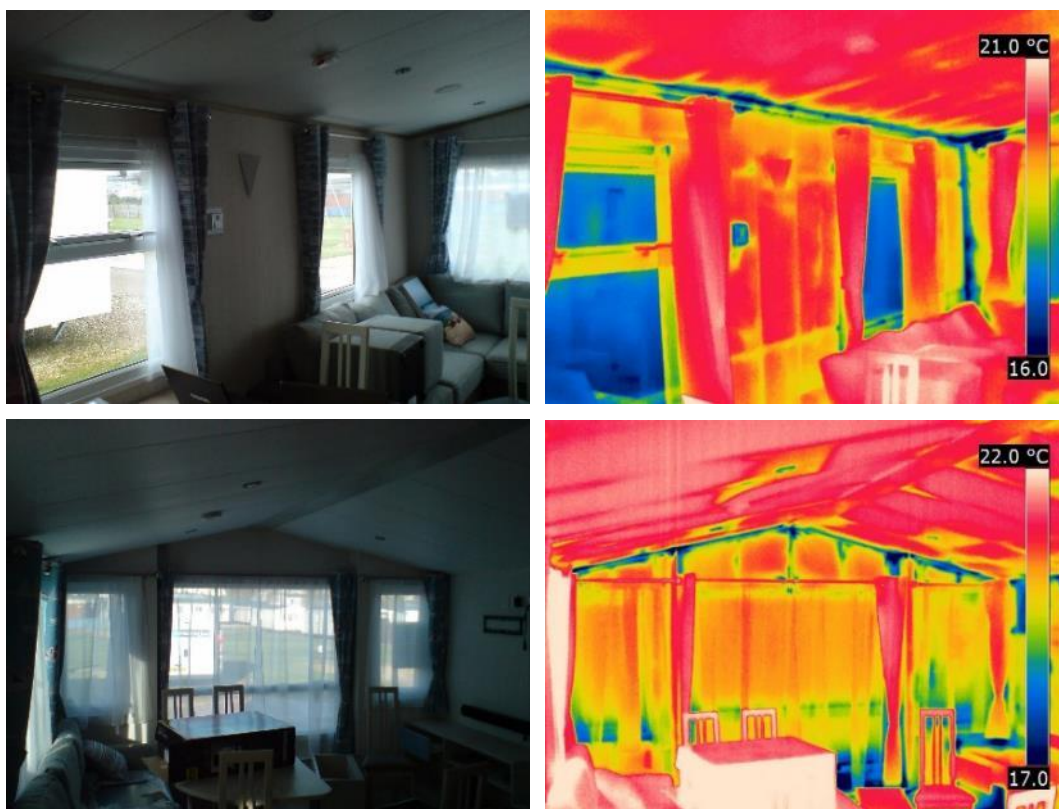
Figure 20 Air leakage at the external wall/ceiling junction (top and bottom) and at external wall corners (top).

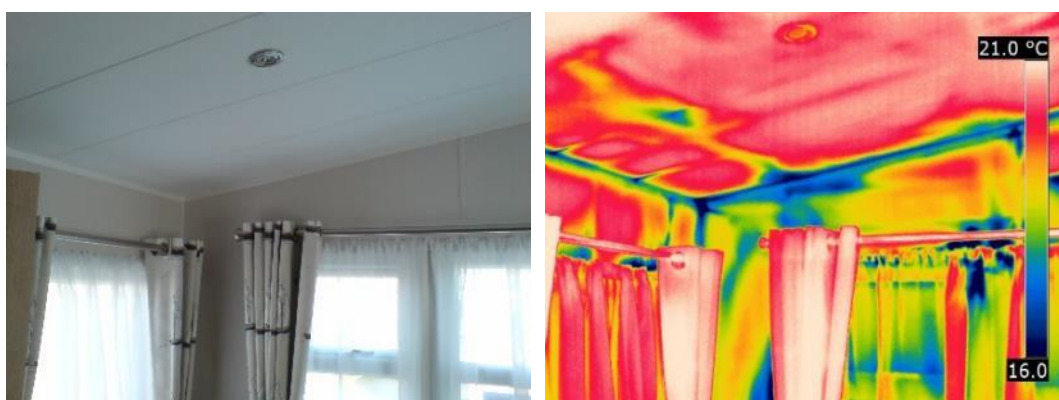
Figure 21 Air leakage at the external wall/ceiling junction in caravan D.

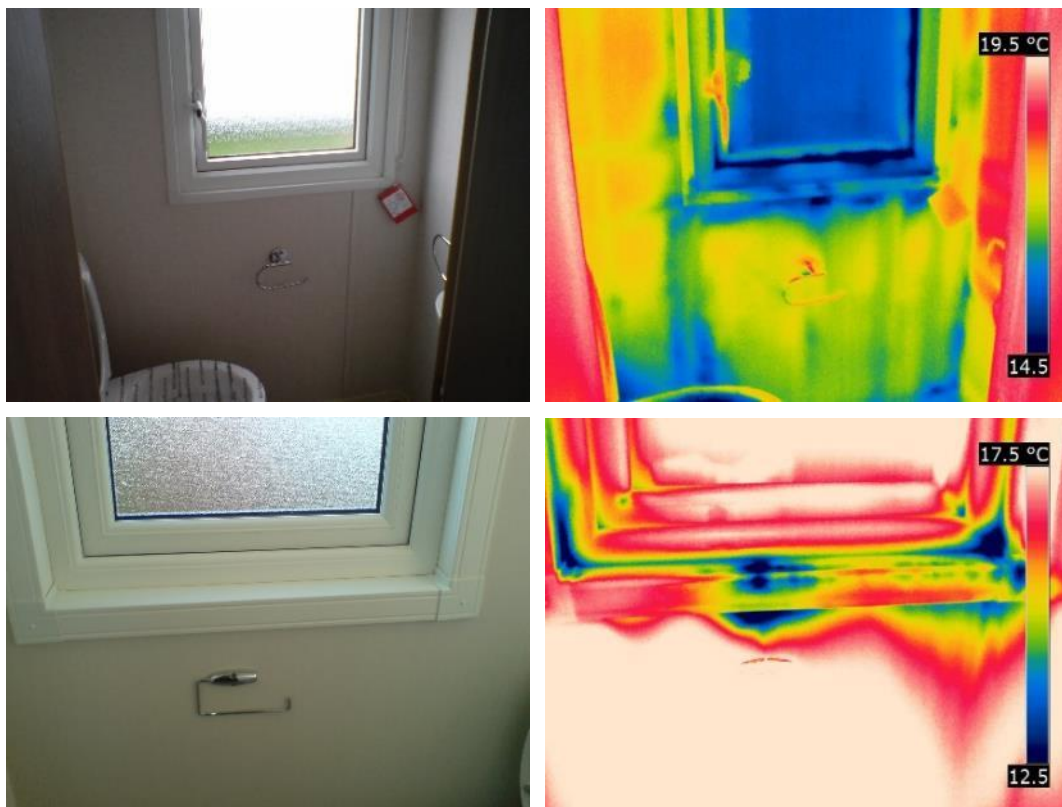
- Around the window frames (see Figure 22).
- 32 In addition, there were a much smaller number of areas of air leakage identified that were specific to particular test caravans. These were as follows:

Figure 22 Air leakage around the window frames.

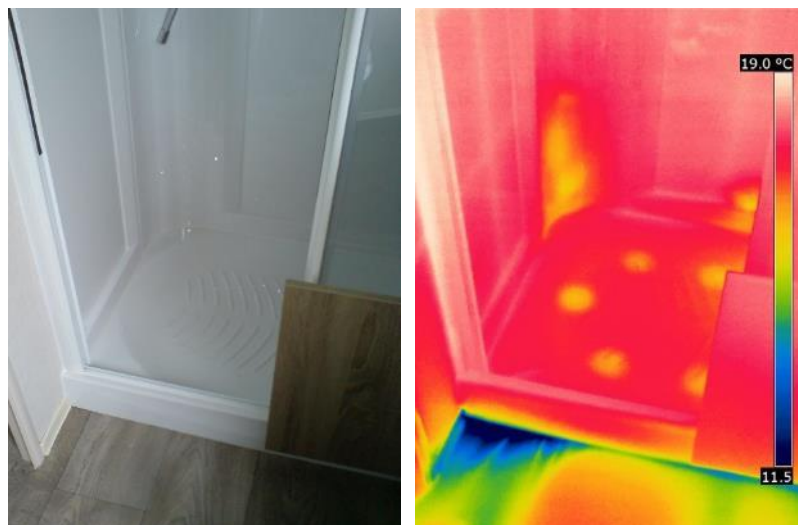
Figure 23 Air leakage at the shower tray/floor junction in caravan B.

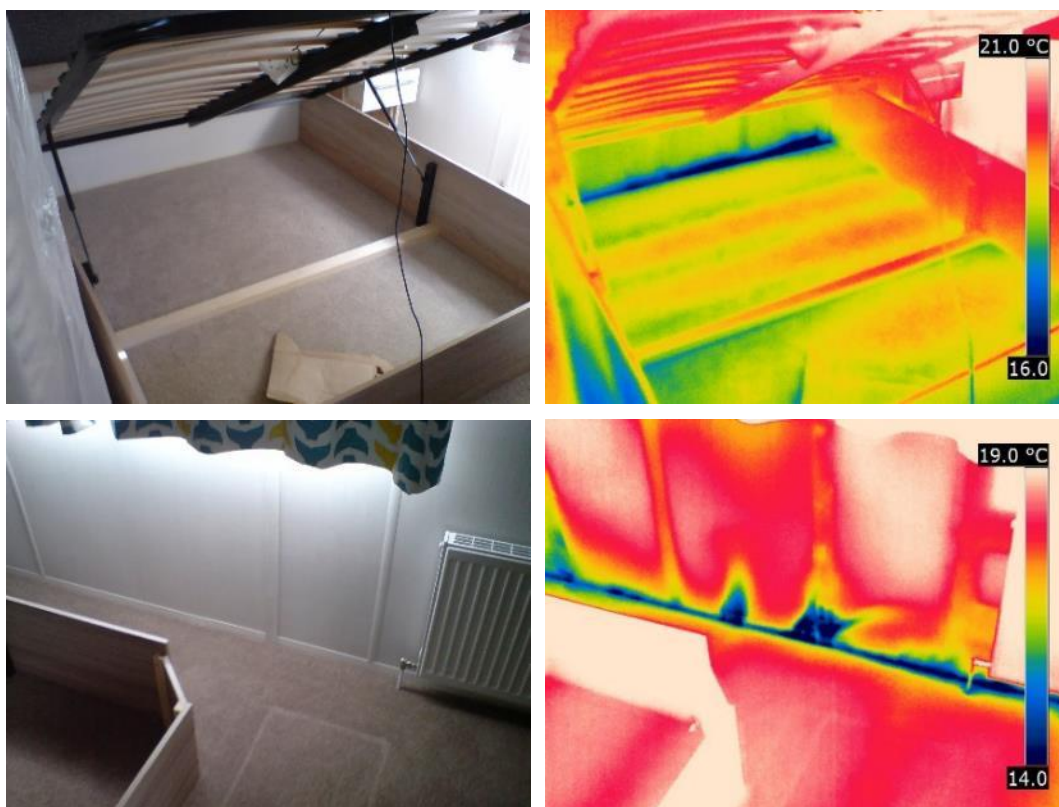
Figure 24 A leakage at the external wall/floor junction in the master bedroom of caravan A (top) and caravan E (bottom).

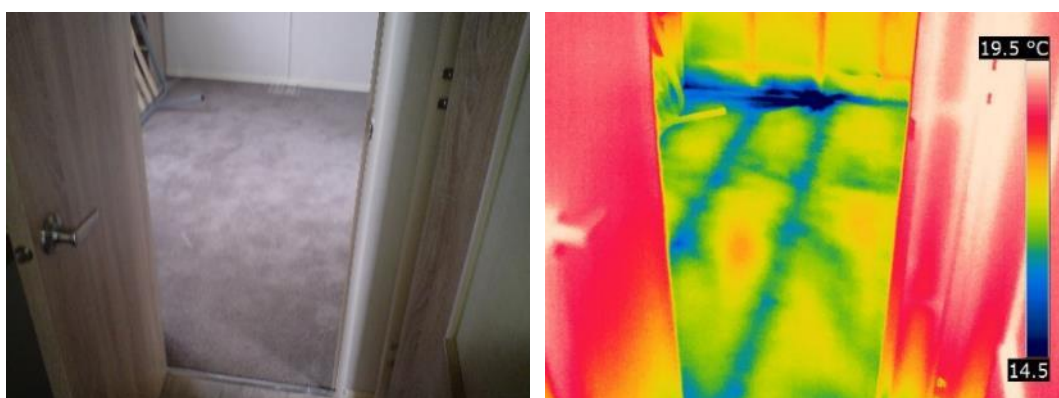
- Beneath the carpet in the master bedroom of caravan B (see Figure 25).
 - Around the front door of caravan C (see Figure 26).

Figure 25 Air leakage resulting in the carpet lifting under depressurisation in the master bedroom of caravan B.

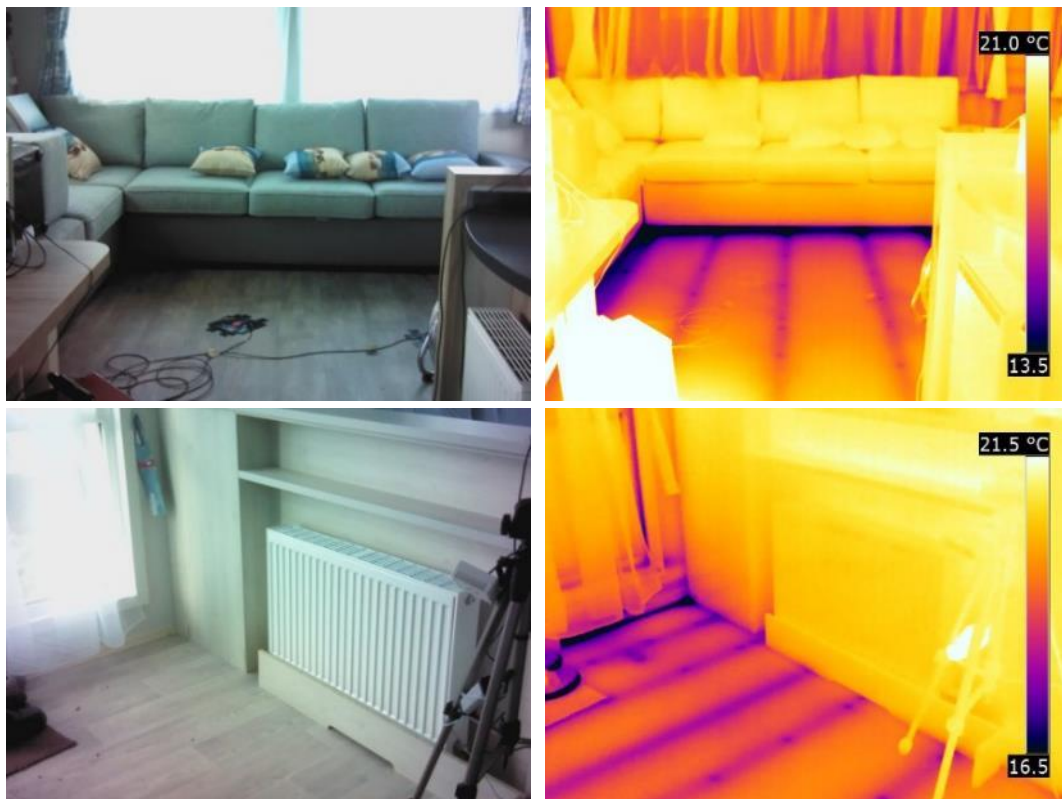
Figure 27 Thermal bridging at the ground floor joists.

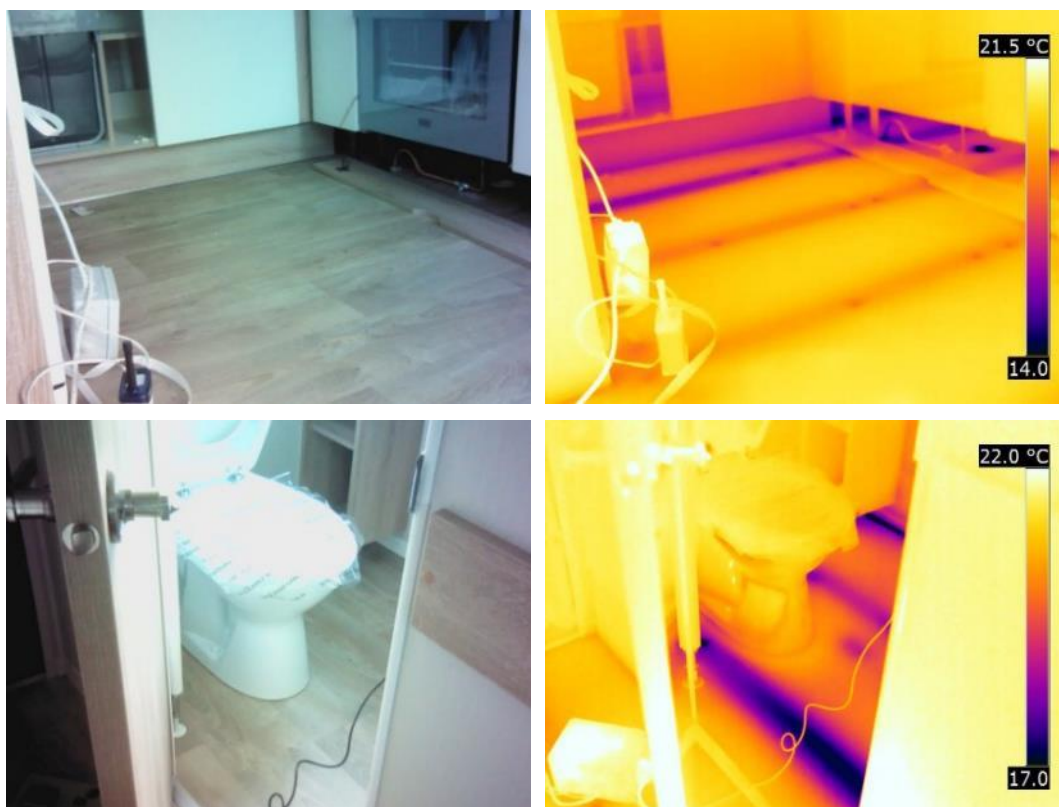
Figure 28 Steel chassis members clearly visible in the kitchen/living area (top) and bathroom (bottom) floor of caravan D.

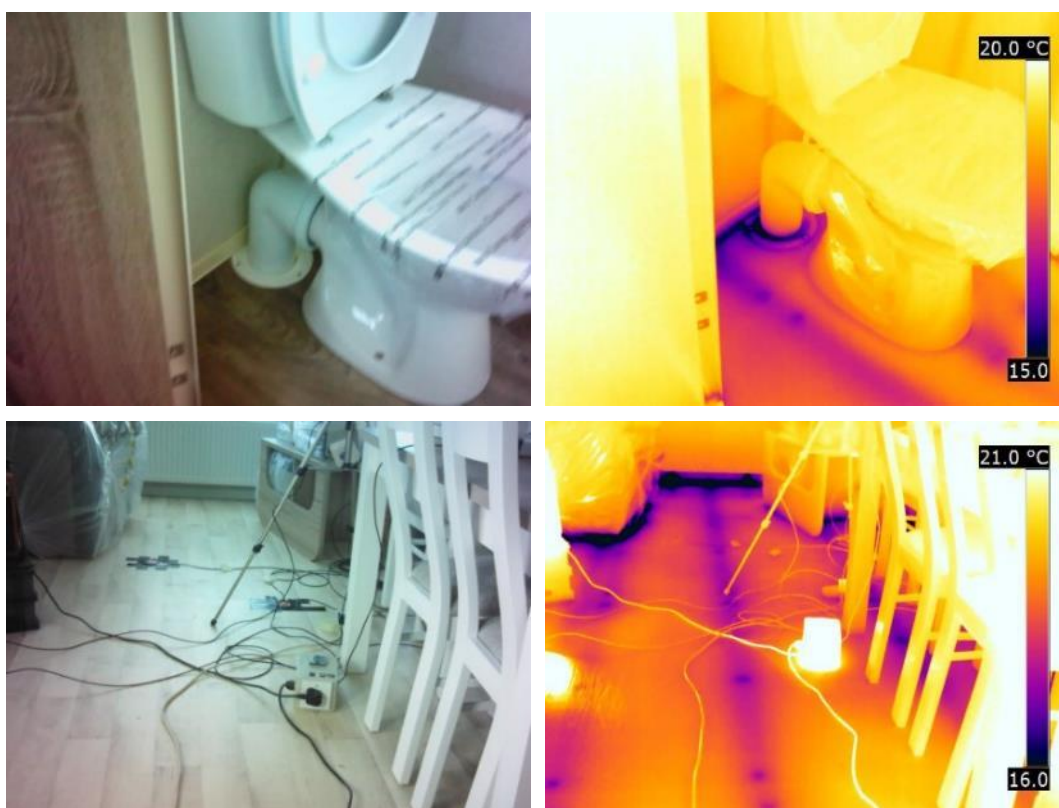
Figure 29 Joist fixings clearly visible on the floor of a number of the test caravans.

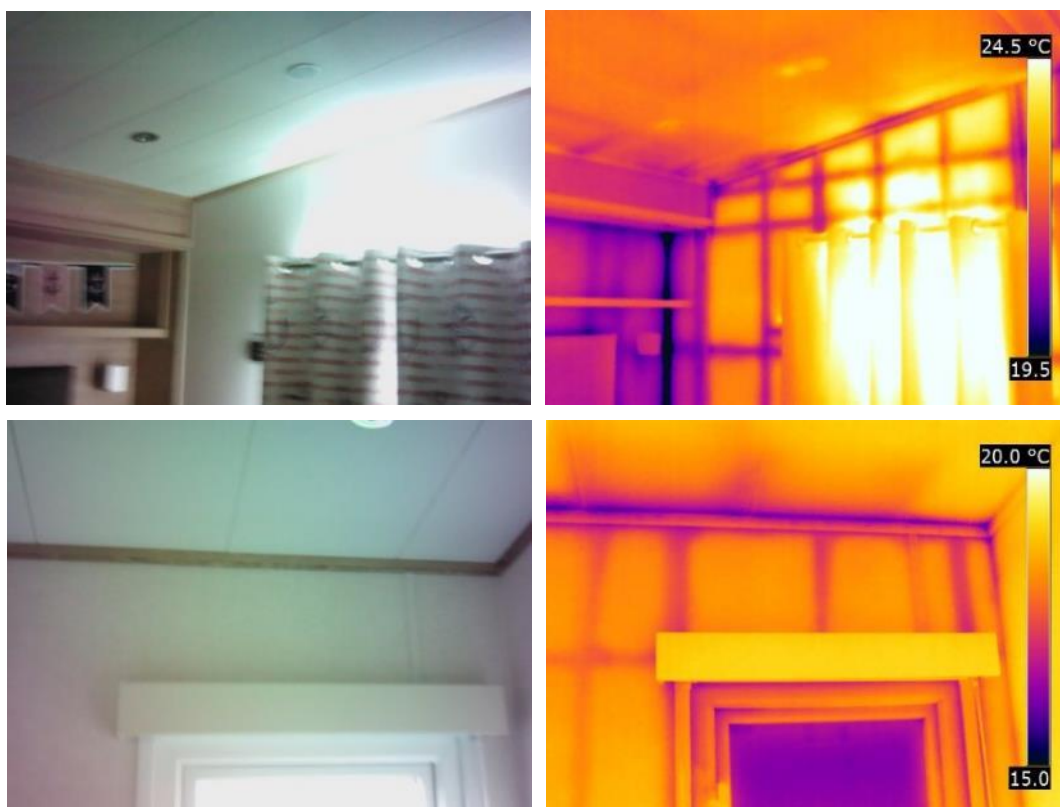
Figure 30 Thermal bridging at the vertical and horizontal studs in the external walls.

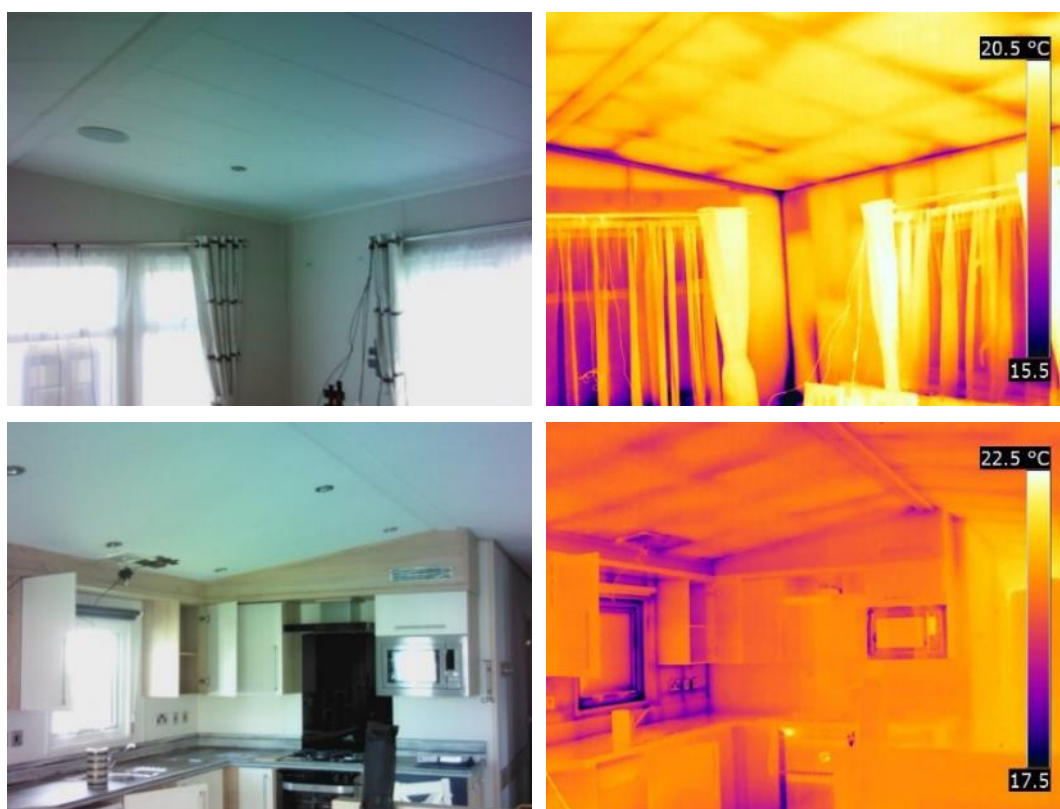
Figure 32 Thermal bridging at the roof joists and noggins.

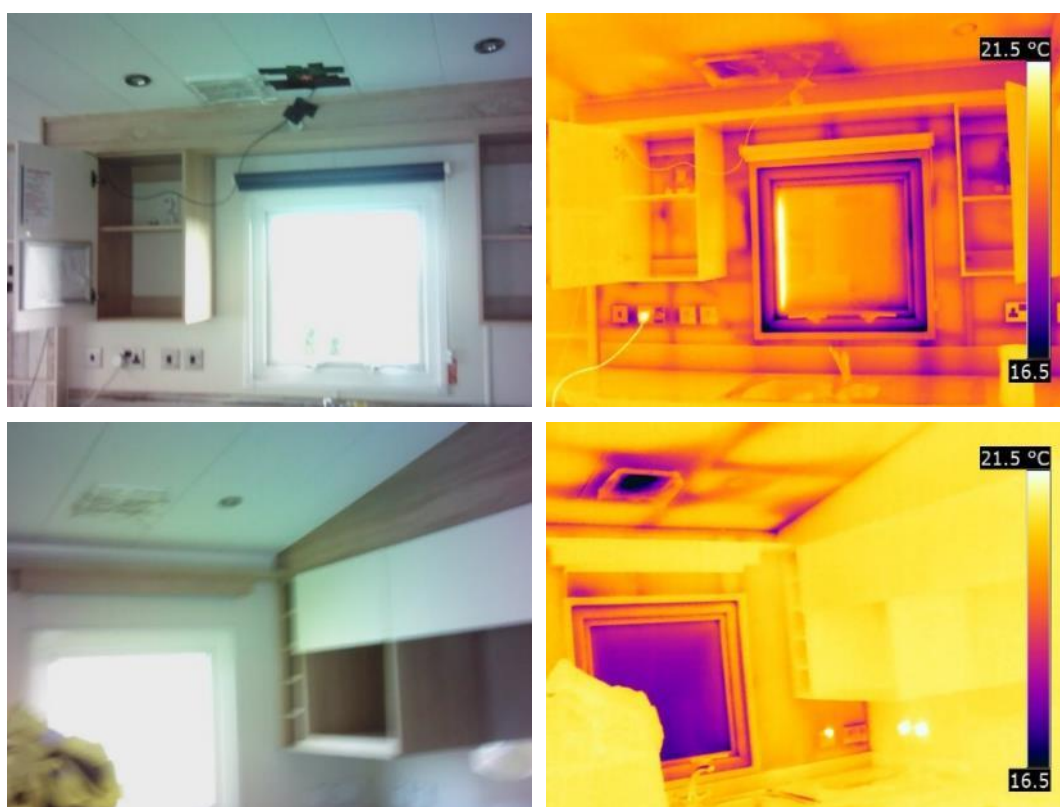
Figure 33 Thermal bridging around the ceiling mounted extract fan in the kitchen/living area.

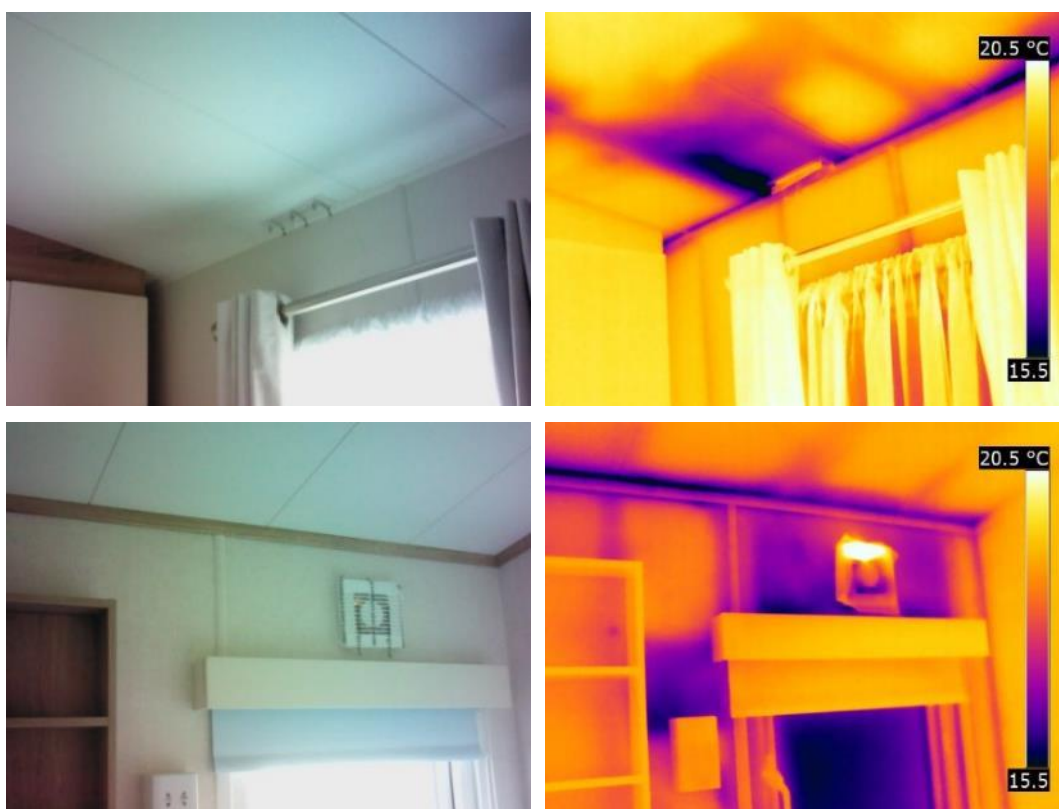
Figure 34 Thermal bridging around ceiling and external wall mounted vents.

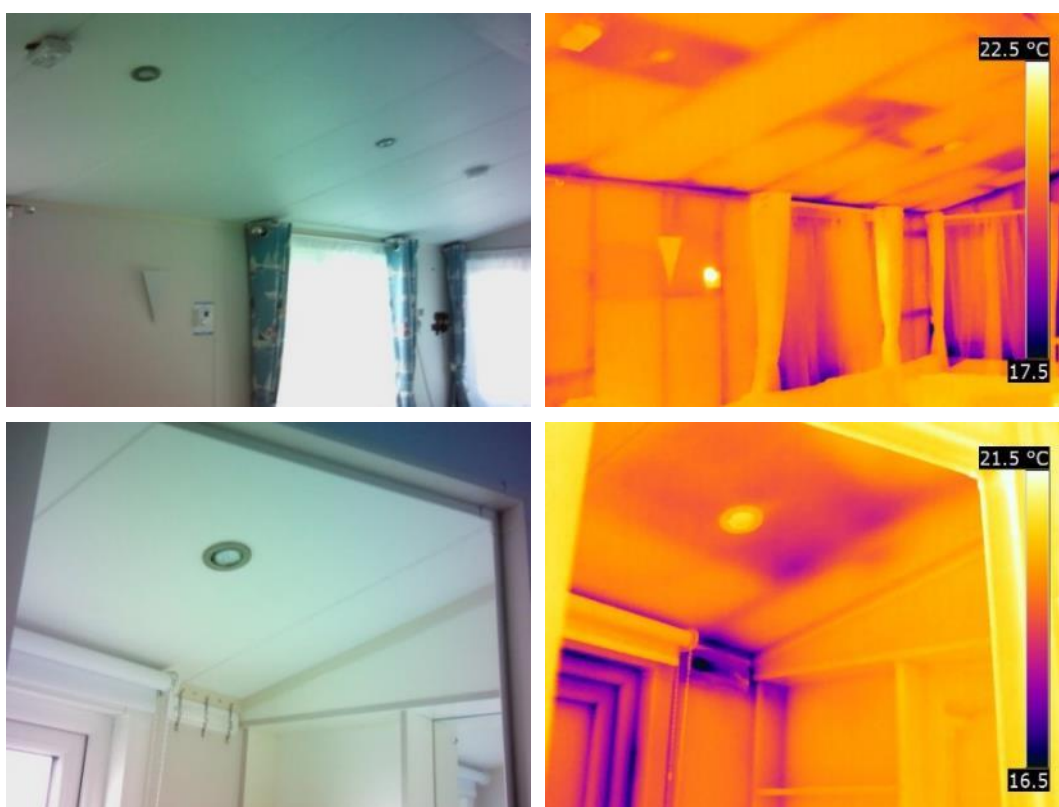
Figure 35 Thermal bridging around spotlights.

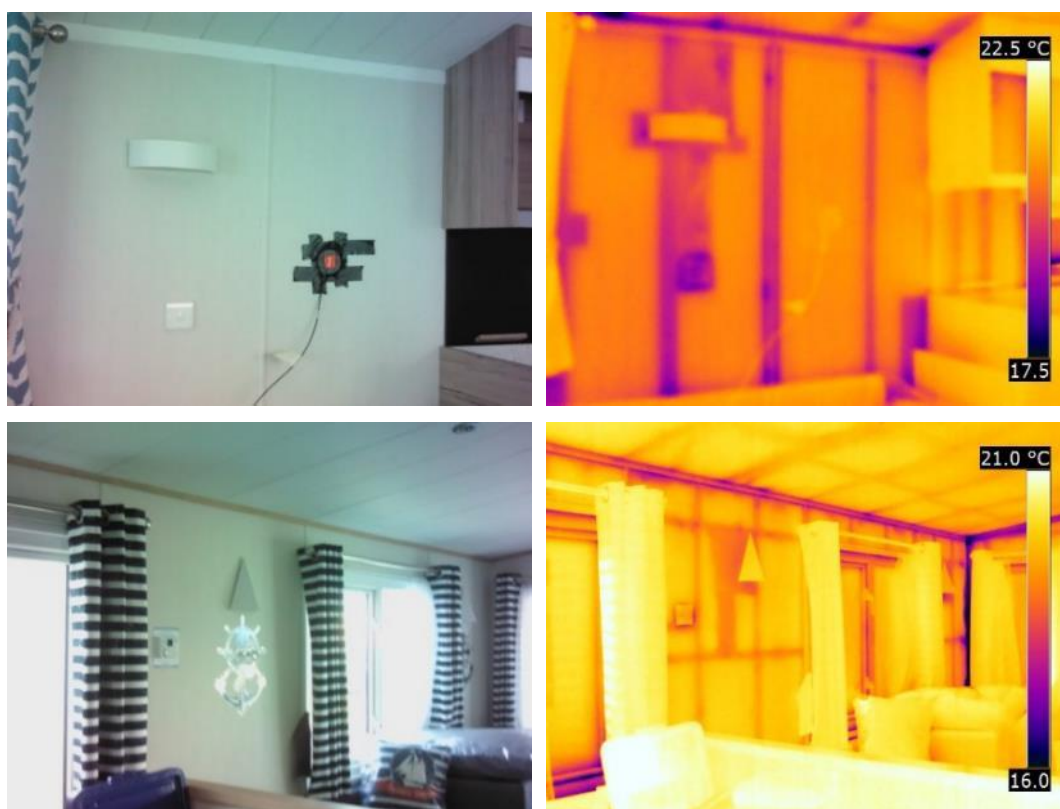
Figure 36 Thermal bridging around wall and light switches, particularly where there are cable runs.

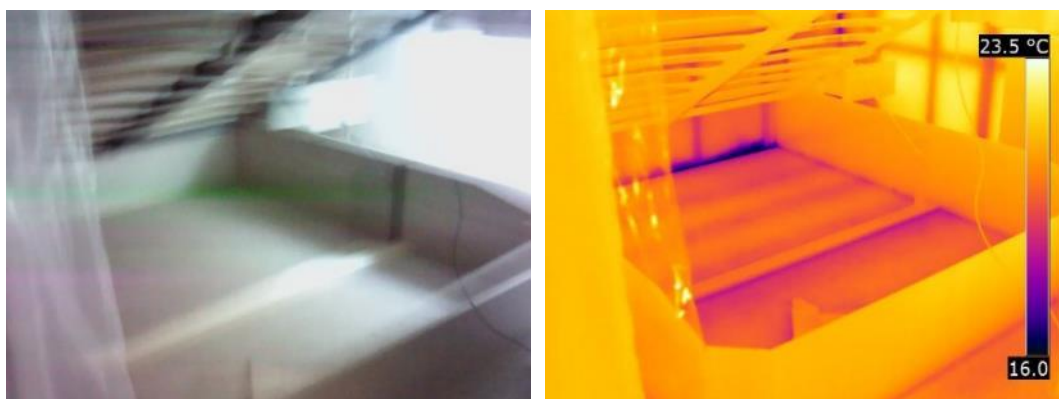
Figure 38 Thermal bridge at the external wall/floor junction in the master bedroom of caravan A.

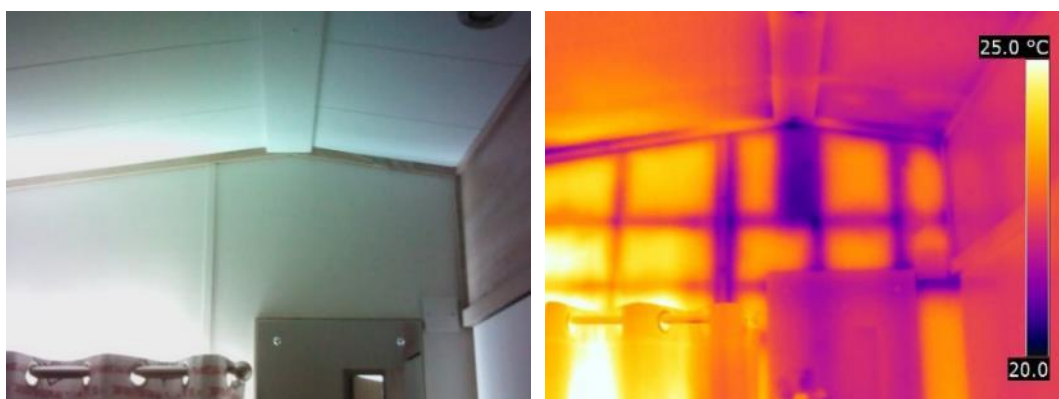
Figure 40 Thermal bridge close to the ridge on the end wall of caravan A.
